# **Network Innovation Allowance**

## **Summary Report**

1 April 2018 to 31 March 2019

Scottish Hydro Electric Transmission

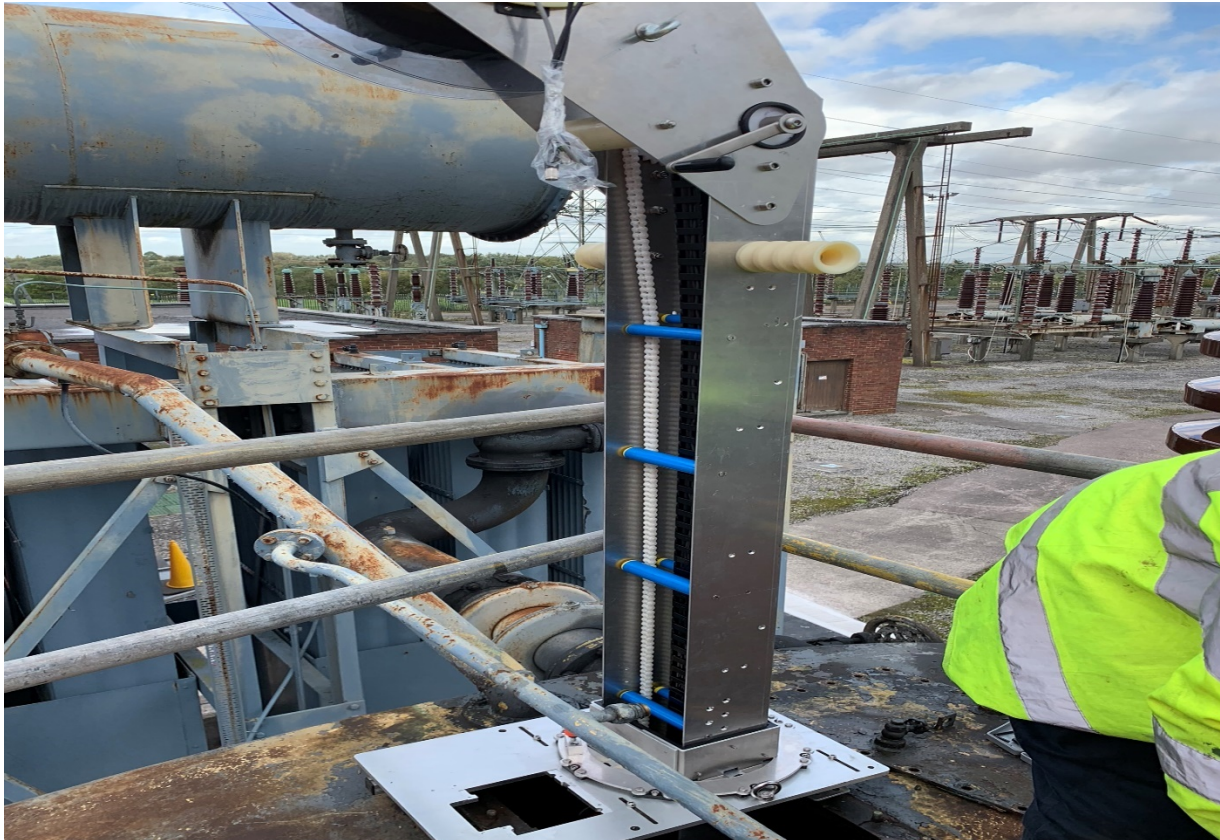
**Figure 2.** Accessing transformer windings with Phase 2 intrascope prototype

The project has progressed with the completion of field trials and closedown. The field trials identified that further development of the intrascope launch mechanism and articulation methods is required in order to progress to BAU deployment. Further details can be found in the closedown report.

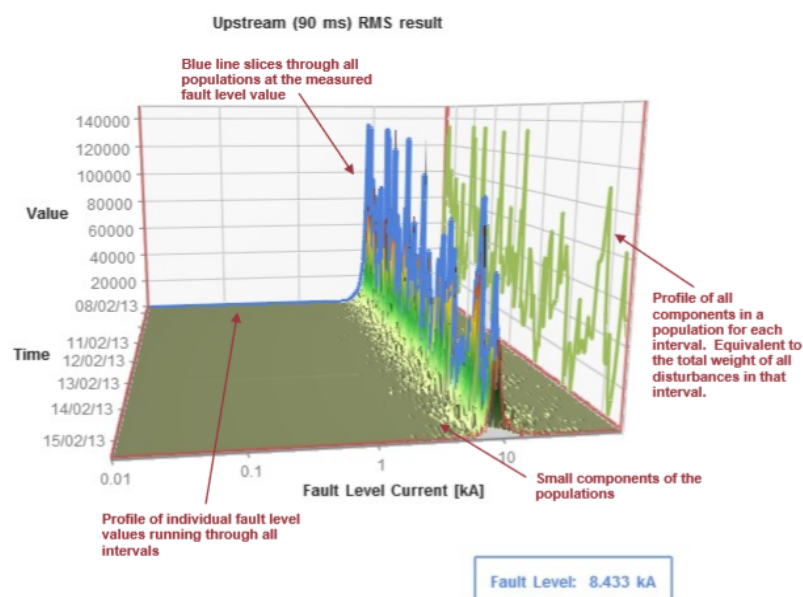
**Figure 5.** Power Quality low-level current raises

Specially designed power quality monitoring equipment was successfully installed in two substations. Evaluating the data collected positively identified infrequent low-level current raises, however when viewed against other forms of fault level monitoring there are consistency concerns associated with the power quality monitoring and repeatability. On reviewing the material, it was concluded that there was insufficient justification to procure further power quality meters.

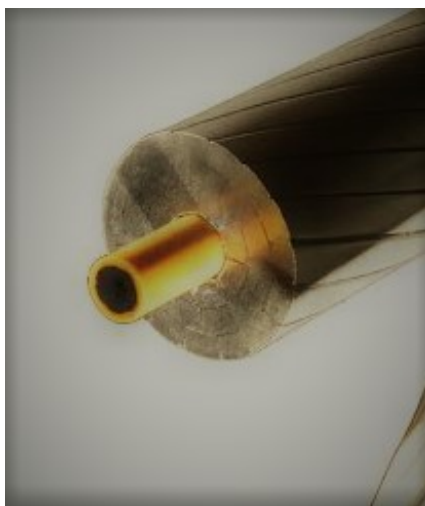
**Figure 9.** Cross-sectional view of the ACCC conductor

mainly been high temperature low sag (HTLS). By operating at higher temperatures, they were able to increase network capacity without a penalty on clearances, but they have had the slight disadvantage of increasing line losses. Unlike ACSR described previously, ACCC uses rather complex materials for its tensile strength as can be seen in the image of the cross section of an ACCC conductor.

Some of the elements visible in Figure 9 and the engineering of the conductor give the ACCC conductor the following attributes:

- The strands are made of annealed Typed 1350-O Aluminium. Annealing improves conductivity leading to greater efficiency which enables cooler conductor operation under high load conditions. This confers the conductor with the 'high capacity' attribute and is responsible for the minimal line losses associated with the conductor.

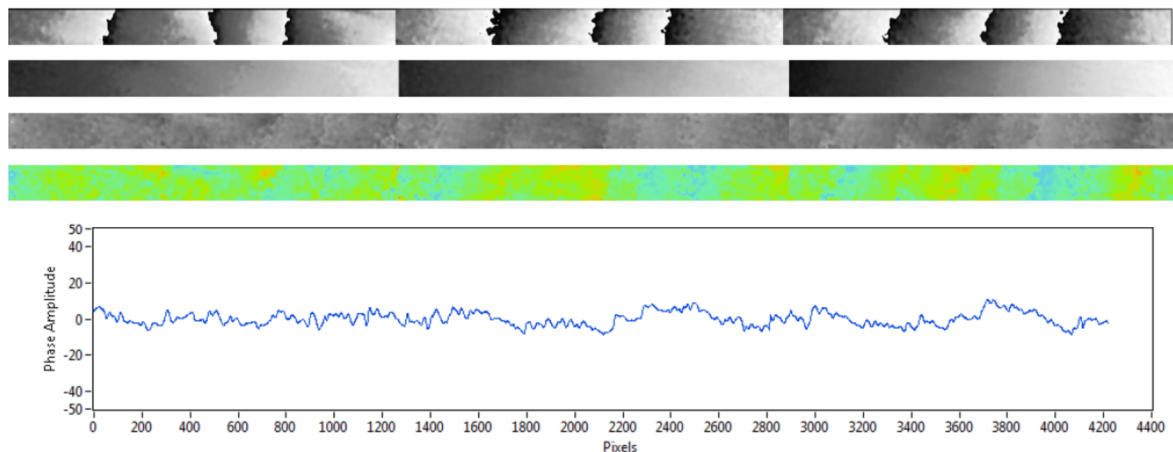
**Figure 15.** Results of the detection of ACCC conductor with an undamaged sample of carbon core

The tests concluded that the damage introduced in the core of the 8m length conductor could be detected by the roving device prototype. The following are two images which show the visual outputs of an undamaged core versus those of a damaged one.

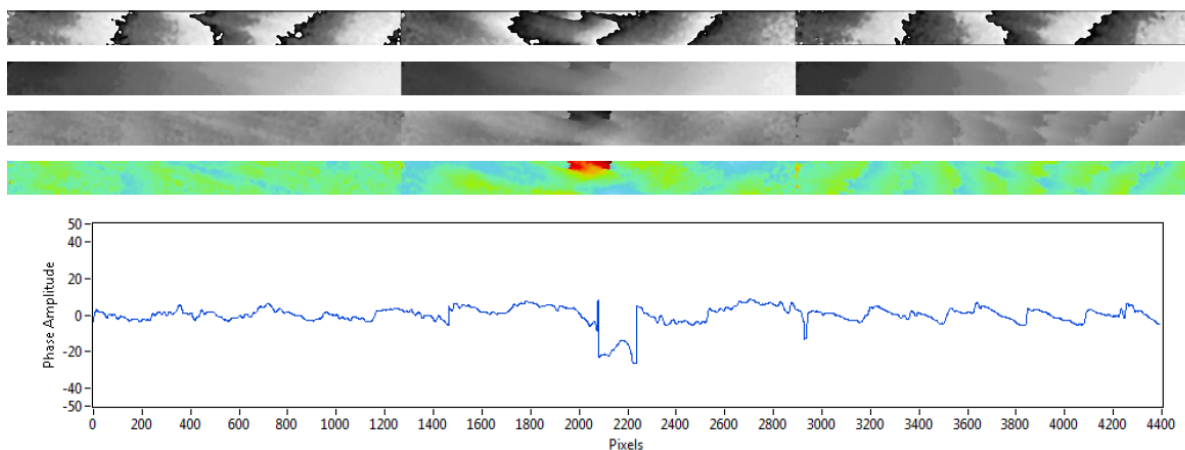
**Figure 16.** Results of the detection of an ACCC conductor with a core cut to a quarter depth and bent around radius approximately 800mm

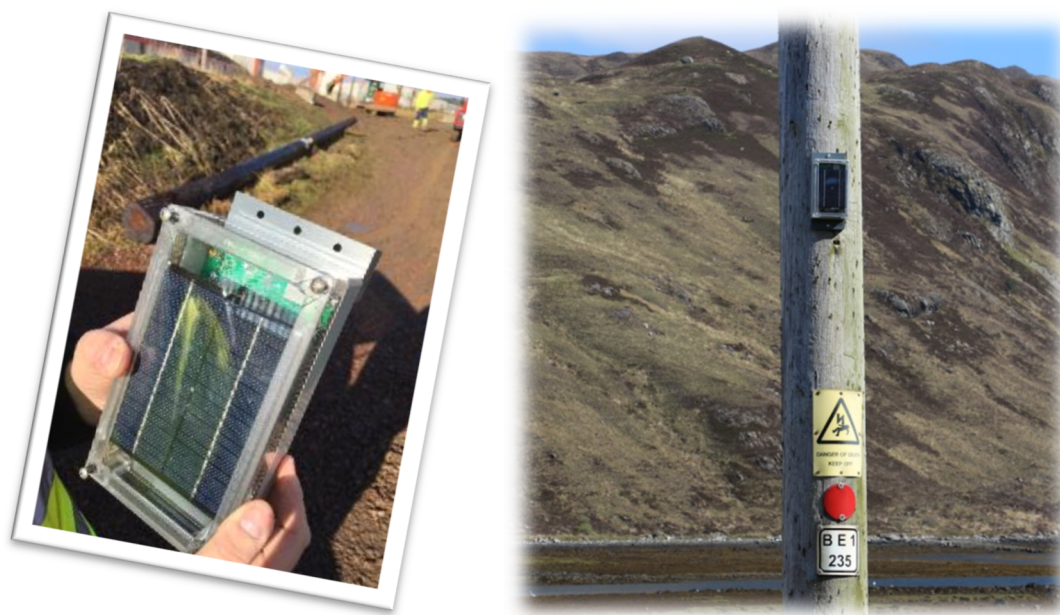
**Figure 17.** Shows the RainMan prototype IoT

It uses the same technology as a mobile phone to detect changes in the movement, within a prototype being housed in an IP67 rated box, with a 5.6 Ah lithium battery and 2-watt solar cell. **Figure 17.** shows several pictures of the pole mounted box. In isolation, the box and each element worked previously with impeccable reliability, interestingly combining the elements has introduced hurdles and after 18month plus of operation 35% of the boxes correspond intermittently.

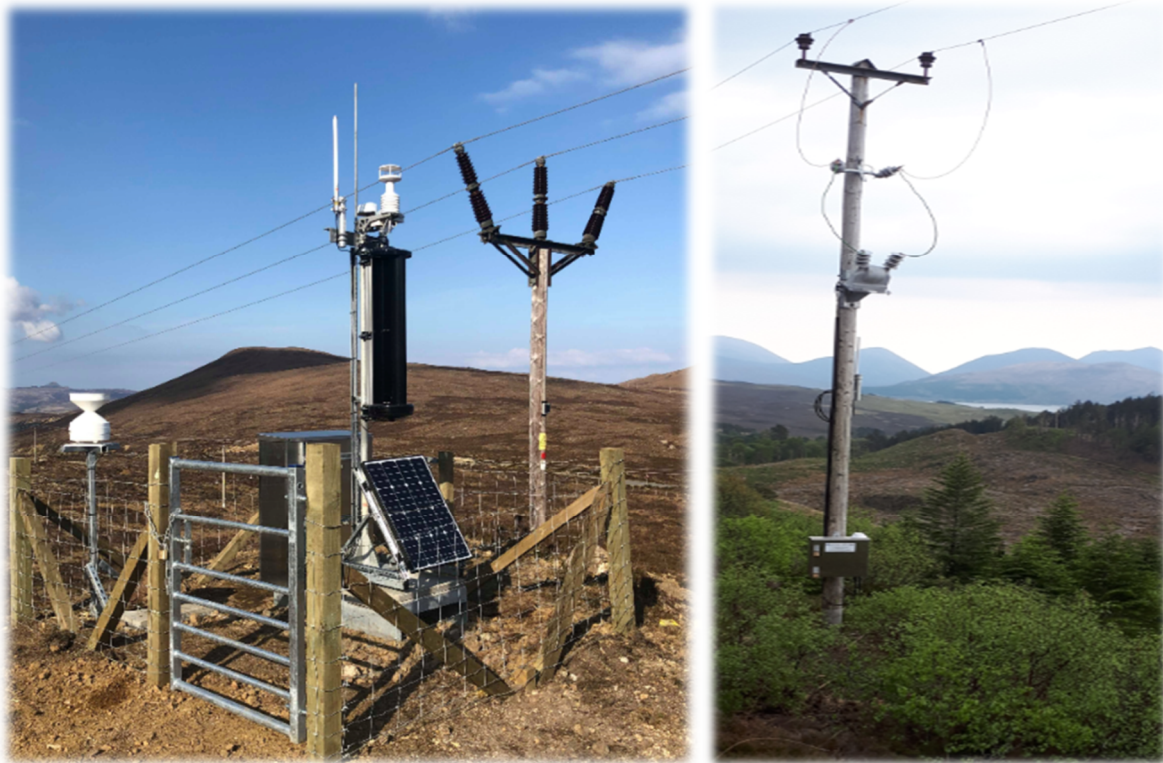
**Figure 20.** Left-hand picture is the stand-alone gateway powered by a solar panel, a vertical wind turbine and a car battery and the right-hand picture shows power tapped using a voltage transformer to feed a pole mounted gateway.

The collection gateways require a constant form of auxiliary power and two of the more unusual ways this has been achieved is a stand-alone combined renewable and battery powered solution and power tapped from an 11kV overhead line, shown below in **Figure 20**.

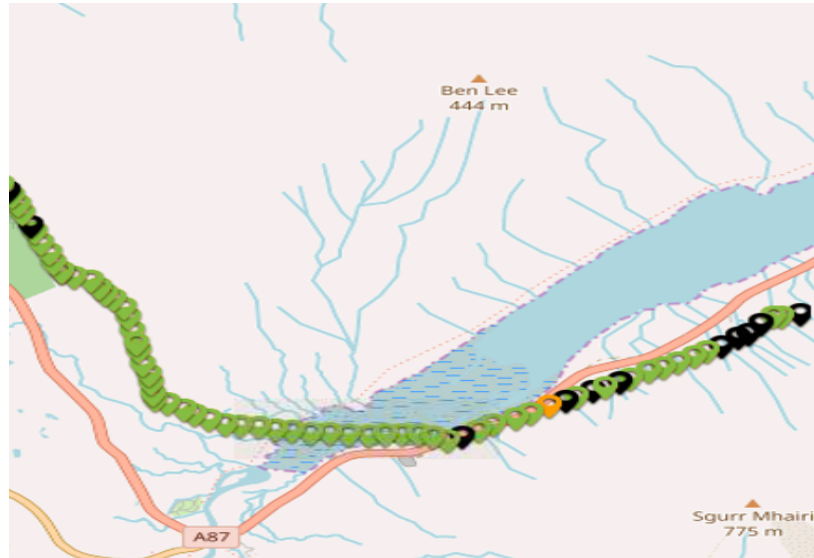
**Figure 21.** The 'Things Network' displaying the IoT pole mounted status

- Green – information has been received in the last 24hrs, the pole is healthy
- Yellow – information within the last 24hrs indicates that the pole is leaning between 10-25 degrees
- Red – information within the last 24hrs indicates that the pole is leaning greater than 25 degrees
- Black – no information has been received in the last 24hrs

The ‘things network’ is a helpful tool which enables information from the IoT pole data to be displayed; it also allows the battery life or position and lean of the pole to be viewed by selecting an active pin. The way in which the information is stored, and the viewing platform means that access to the web-viewer can be specifically assigned, there are positives as it presently by-passes internal hurdles associated with external information being incorporated within internal systems. Looking to the future, it’s not practical to have a standalone web-viewer therefore investigation is underway with the SSN Geographic Information System (GIS) Team to determine how the RainMan information could be displayed on their systems.

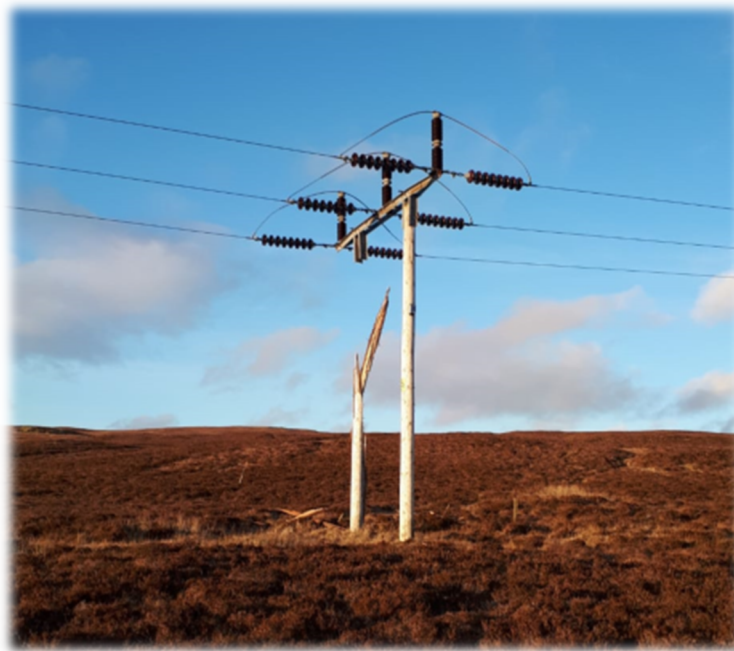
**Figure 22.** The aftermath of a lightning strike

On the 2<sup>nd</sup> March 2018, at 23.52 pole ED-043 was struck by lightning, the results of which can be seen in **Figure 22**. The pole that failed was not the one that had the pole mounted IoT attached. However, in assessing the movement information prior to and post the event, it was observed that the pitch of the pole (the orange dots in **Figure 23**.) were out of character. This event has been pivotal in the direction of the RainMan Project as it shows that pole snaps can occur and monitoring the lean of

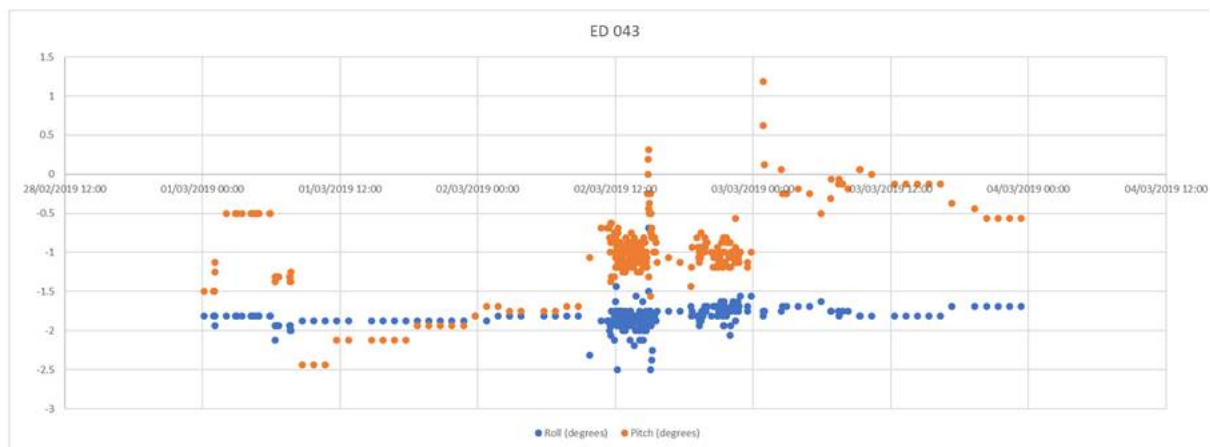
**Figure 23.** Pole movement before and after the lightning strike, the orange dots are out of character

the pole alone may not correctly identify a broken pole. Work is now ongoing into building a data analytic tool that will compare movement information prior to and after an event.
