Electricity
Transmission

EIP142 - Non-Intrusive and Cost Effective Method for Corrosion Measurement

13 Feb 2025
ENA Basecamp

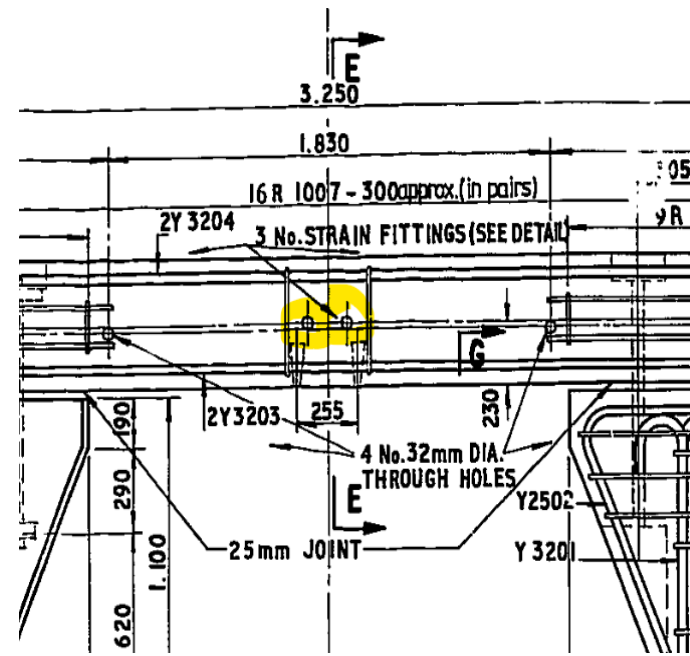
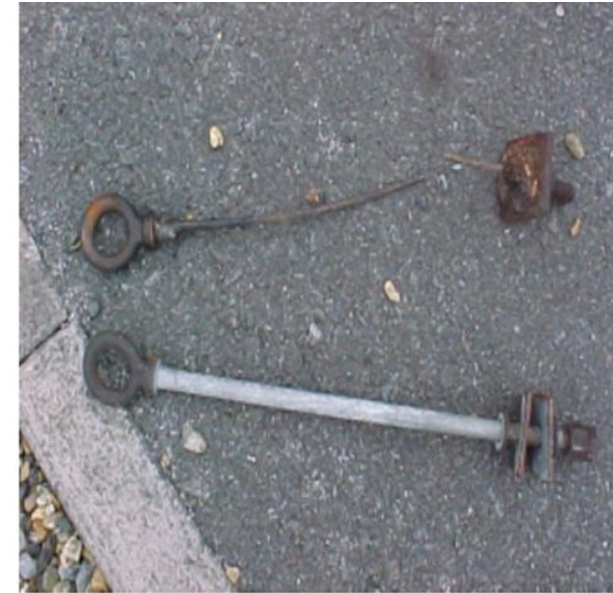
PLAN

Through bolts are fasteners that pass completely go through the top of gantries with an insulator attached at either side providing a secure connection between components. They typically consist of a threaded rod or bolt that is inserted through a hole, secured with a nut and washer on the opposite side.

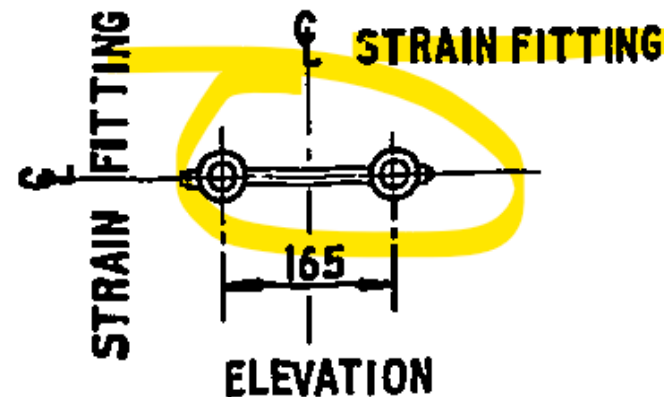
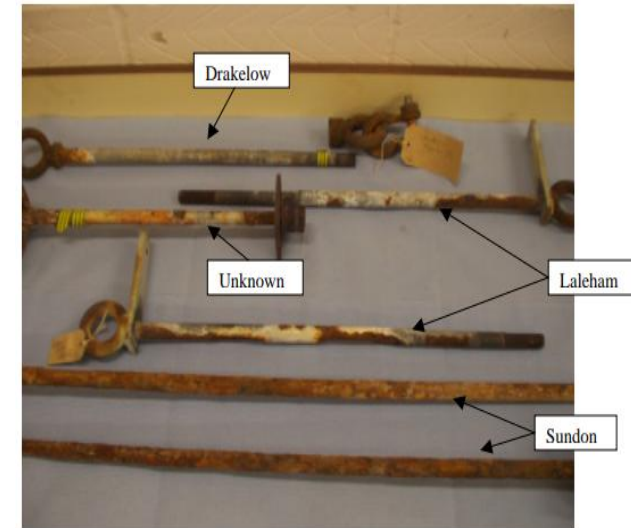
Corroded through-bolt failure

- Through bolts corrode in concrete structures, gantries, and switchgears. This is likely caused by repeated wetting and drying of the bolt.
- High water retention in the mounting hole contributes to the issue.
- This can compromise structural integrity and lead to failures in the connections they secure.
